Report No. CG-D-13-15

Evaluation of Rutter Sigma S6 Ice Navigation Radar on USCGC Healy during Arctic Shield 20

March 2015

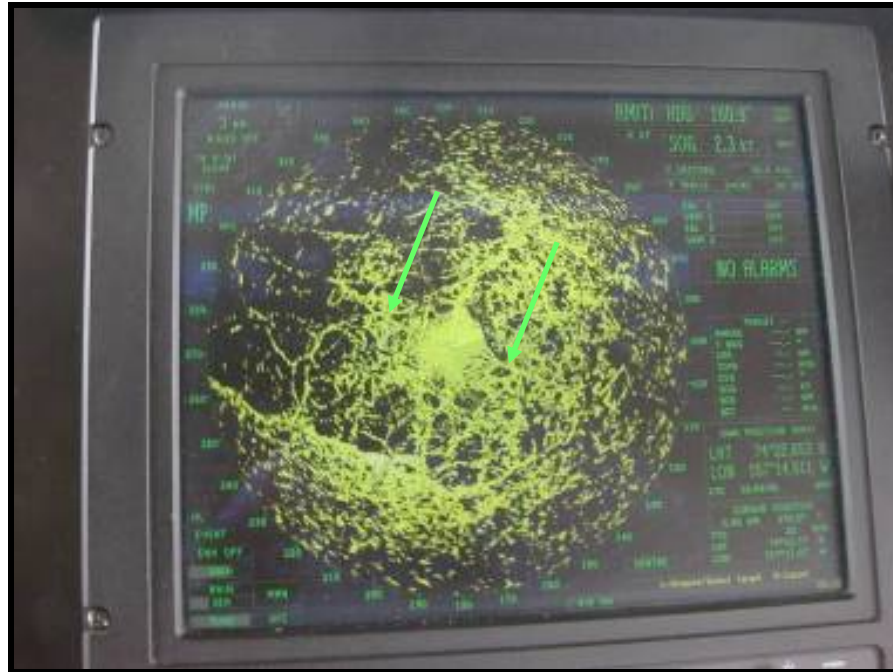
Figure 33. CG radar display of pressure ridge (3 nm range scale).

Pressure ridges are important features in ice fields that navigators should be aware of. They are a result of two ice floes coming together to create thick strips of ice that become potential barriers for icebreakers. It is more effective, if there is no option to avoid them completely, to run into them perpendicularly while the ship has momentum. It is important to spot them on radar displays ahead of time so navigators may be prepared to either run into them perpendicularly or to avoid them completely. On August 20 at 6:42 PM, a large pressure ridge was detected on both the Ice Navigation and CG radar displays and this particular ice feature can be clearly discerned in Figures 31 to 32 (see green arrows). It takes more effort to notice this pressure ridge on the CG radar (See Figure 33).

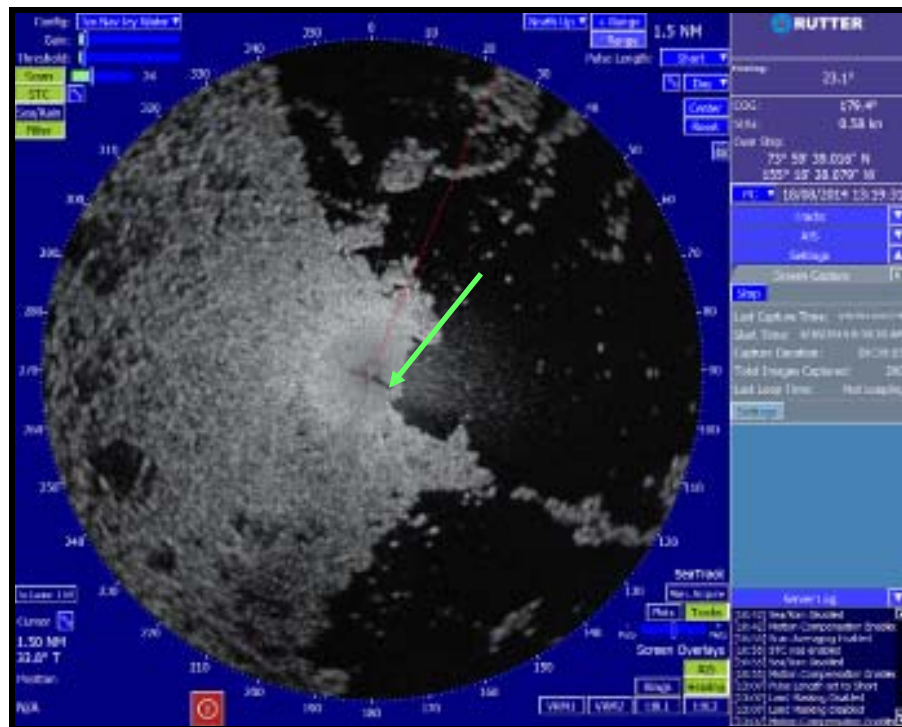
Figure 35. ASB at the start of clearing a path to open water (1.5 nm range scale; arrow indicates location of vessel heading roughly east and the track behind).

During a technology demonstration on August 18, USCGC Healy drifted inside an ice field characterized with loose ice after arriving at a body of open water. Instead of powering up the ship's propellers and moving back into the open water for release of the Arctic Small Boat (ASB), the ASB was deployed into a small opening in the ice field and pushed its way back into the open water. It acted as a snowplow and pushed one piece of ice floe at a slow but steady clip until it reached open water. The ice-clearing path was captured by the Ice Navigation radar with clarity (See Figures 35 to 38), which impressed the ship's crewmembers.

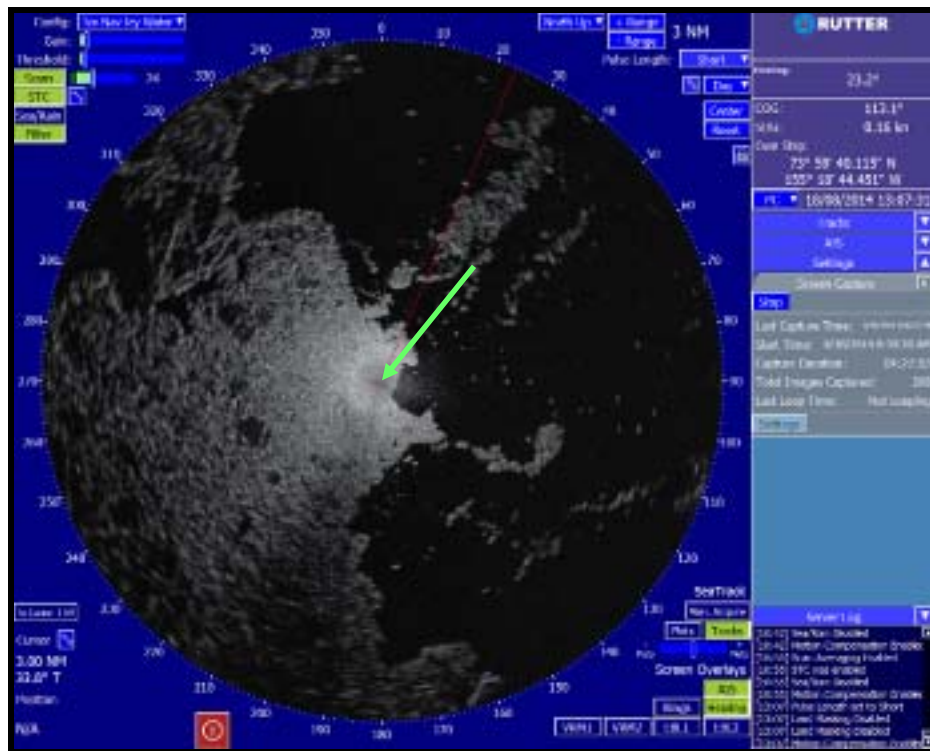
Figure 36. ASB clearing a path to open water (3 nm range scale; arrow indicates location of vessel heading roughly east).

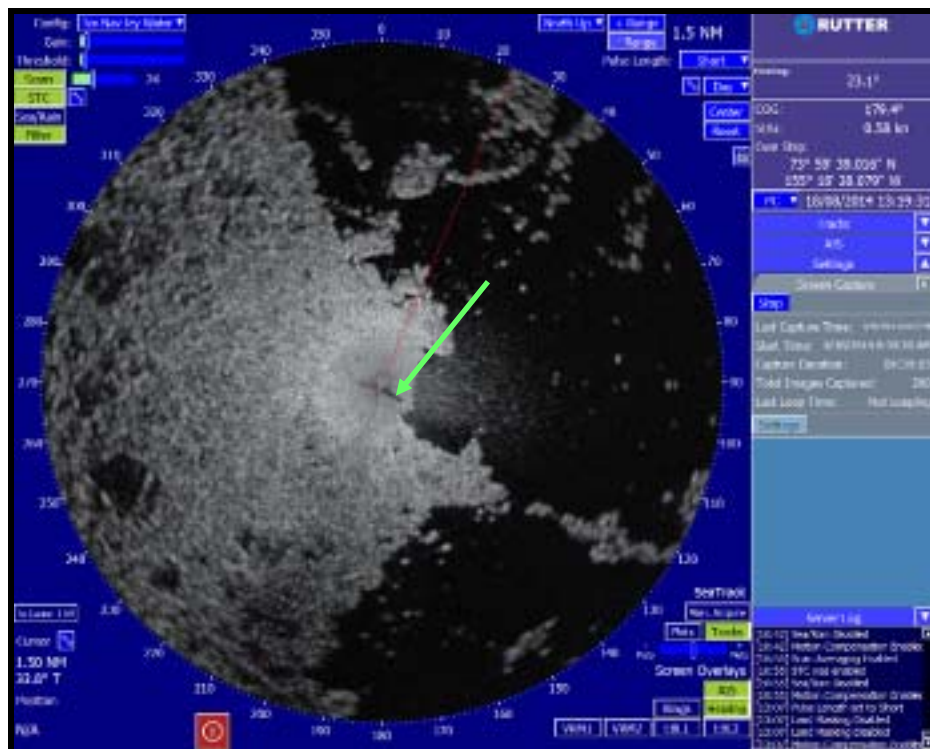
Figure 37. ASB reaching the open water (1.5 nm range scale).

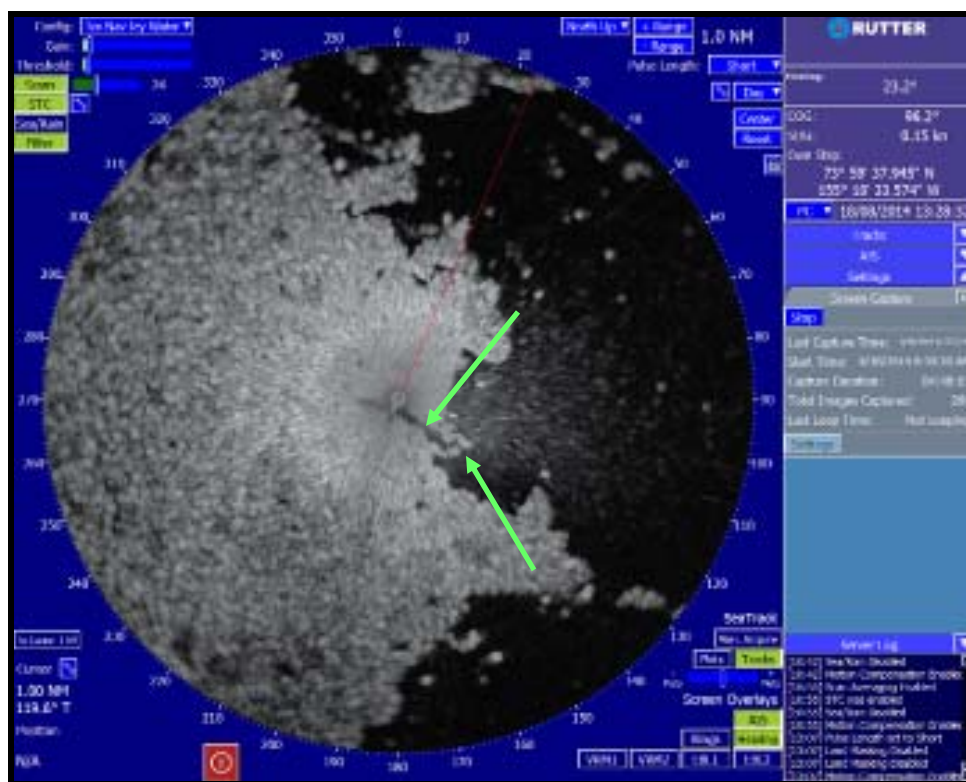
Figure 38. ASB in the open water (1 nm range scale; arrows indicate the path created by the ASB and that it reached the patch of open water).

The capture of the ASB clearing a path for itself demonstrates an added utility for the Ice Navigation radar. Not only does it detect the ice edge and type of ice with high resolution images but it can also provide improved situational awareness of polar operations that the USCGC Healy routinely performs. The radar can be extremely useful in assessing the safety of the crew, particularly in poor weather conditions when visibility is near zero.

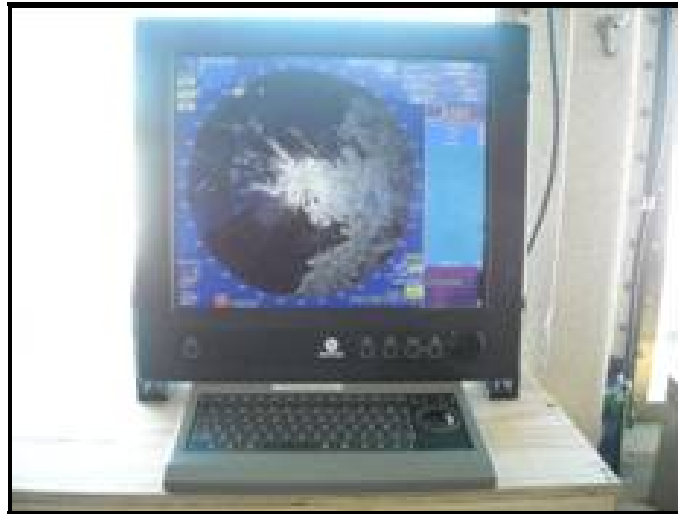
Figure A-1. Rutter Ice Navigation radar display with radar display turned on.

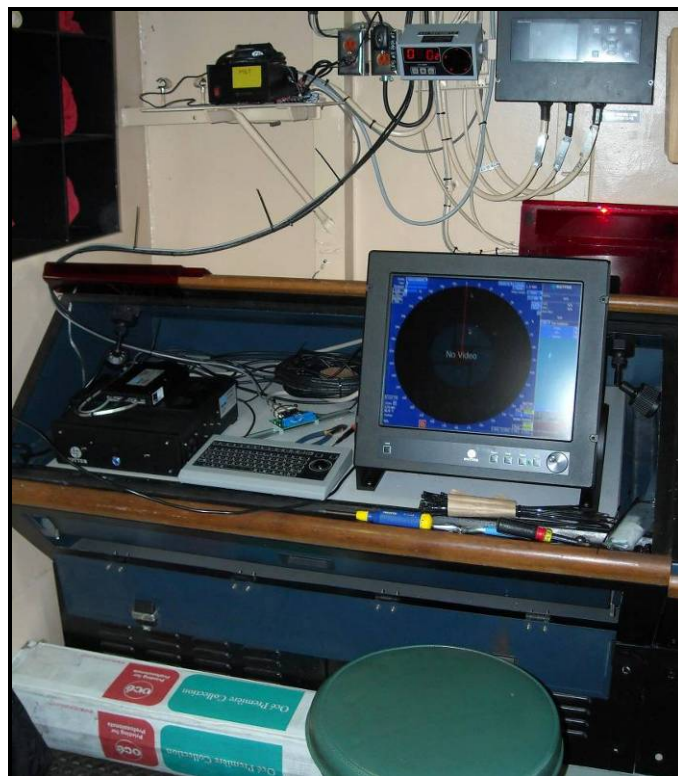
Figure A-2. Rutter Ice Navigation radar setup in the Chart Planning Station on the USCGC Healy.

The key to this processor is that it processes a full dynamic range of data (12-bit video) versus the 2-4 bit intensity in standard navigation radar that are more than adequate to identify other vessels, buoys and points of land. This processor then is able to produce a higher-quality image for better ice definition (see Figure A-1). The processor uses the standard X-band out (Analog) usually set on a short pulse for better resolution. Figure A-2 shows setup of the processor and monitor in the Chart Planning Station on the USCGC Healy.
